Installation and Troubleshooting Guide

CDI P/N 123-7567

NOTE: This install sheet covers the 123-7567 Electronic Shift Assist (ESA) module for boats equipped with the electronic Prestolite BID (Breaker-less Ignition) distributor and a harness using a single 5 pin connector for the ESA. If your boat has any other type of distributor than a Prestolite BID or a two plug ESA connection, please call CDI for a cross reference.

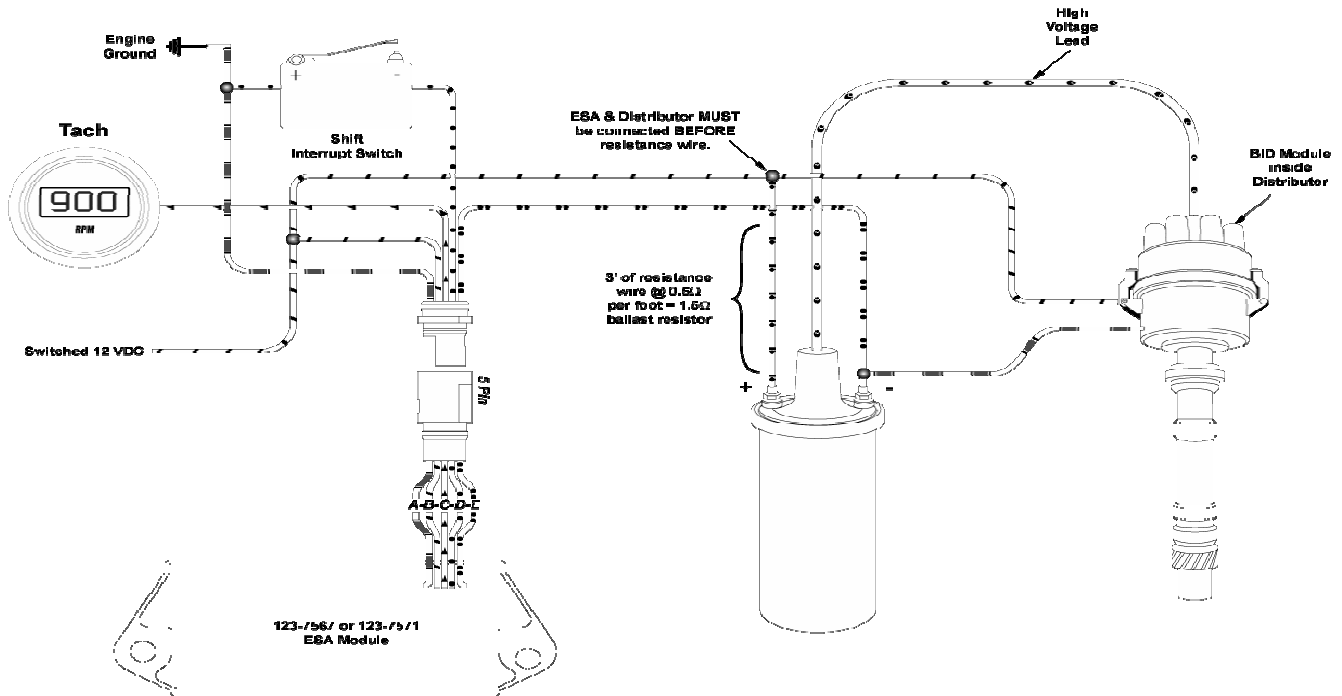
Step 2- Measure circuit resistance between Gray and Violet wire

Step 3- Calculate how much ballast resistance to add.

- Black
- Grey
- Gray/Black
- Blue
- Violet
- Violet/Red
- III-Voltage Lead

3. Verify correct Ignition circuit resistance. (See Page 2)
 - A) Measure resistance of the coil (Step A). Normal coil resistance should be 1.5Ω , if less resistance is found a higher resistance ballast resistor may be needed.

- C) If either reading in step A or B is not correct Perform engine stalls during shift Troubleshooting and then select proper ballast resistor, or contact CDI Tech Support for further help.
