CDI P/N 123-9898-P

NOTE: This install sheet covers the 123-9898-P Electronic Shift Assist (ESA) module for boats equipped with a distributor using mechanical breaker points or an aftermarket electronic points replacement kit. If your boat has another type of distributor please call CDI for a cross reference to the correct part for your application.

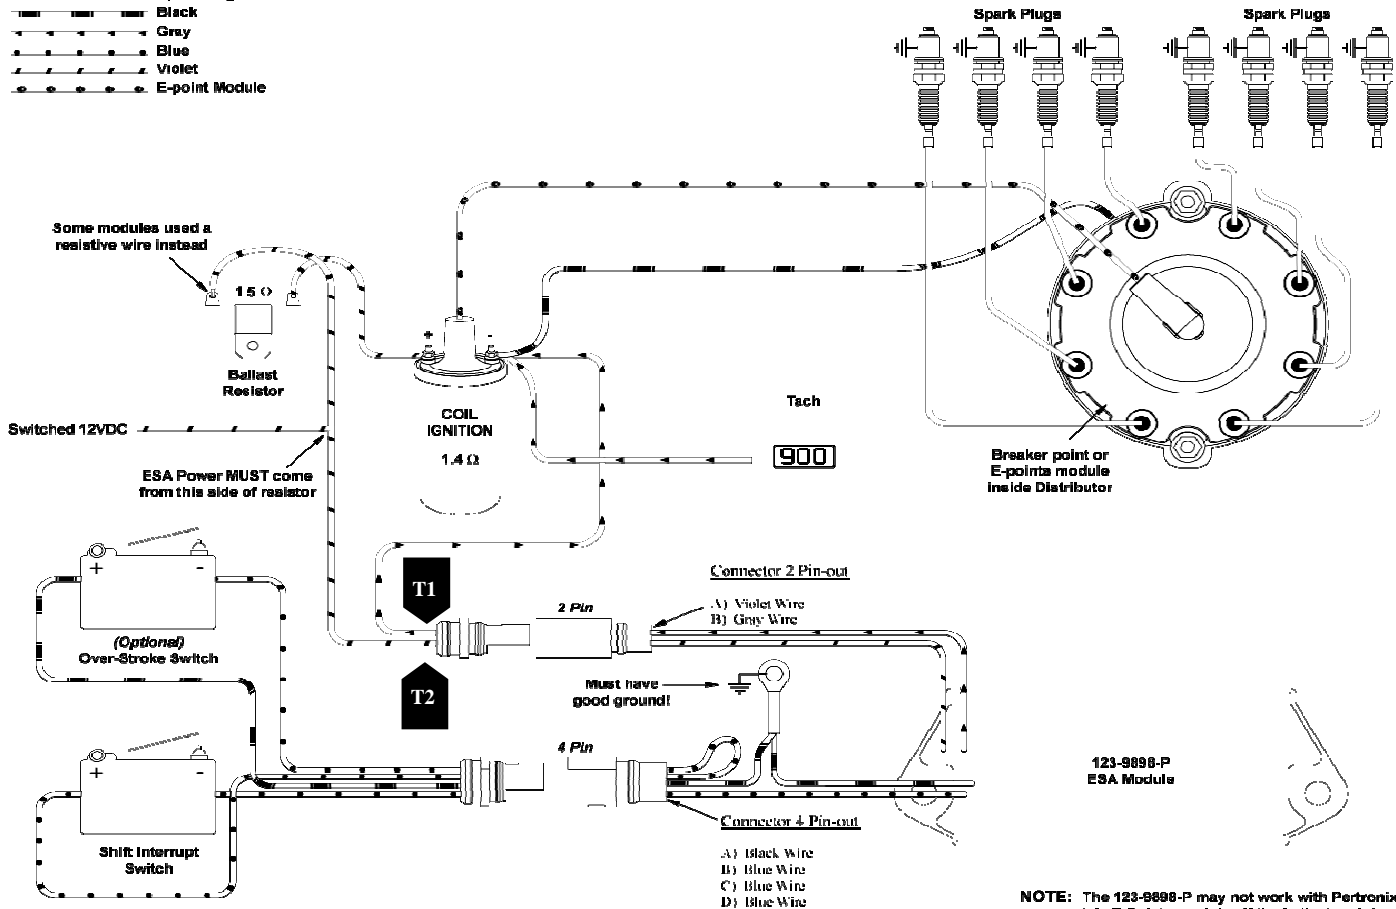
Step 2- Measure circuit resistance between Gray and Violet wire
See Diagram below

- Spark Plug
- Black
- Gray
- Blue
- Violet
- E-point Module

3. Verify correct Ignition circuit resistance. (See Page 2)
 - A) Measure resistance of the coil (Step 1). Normal coil resistance should be 1.5Ω, if less resistance is found a higher resistance ballast resistor may be needed.
