The Original Engine Cooling Pump Since 1921

17000 Pump Series Technical Guide

Assembly / Disassembly Instructions

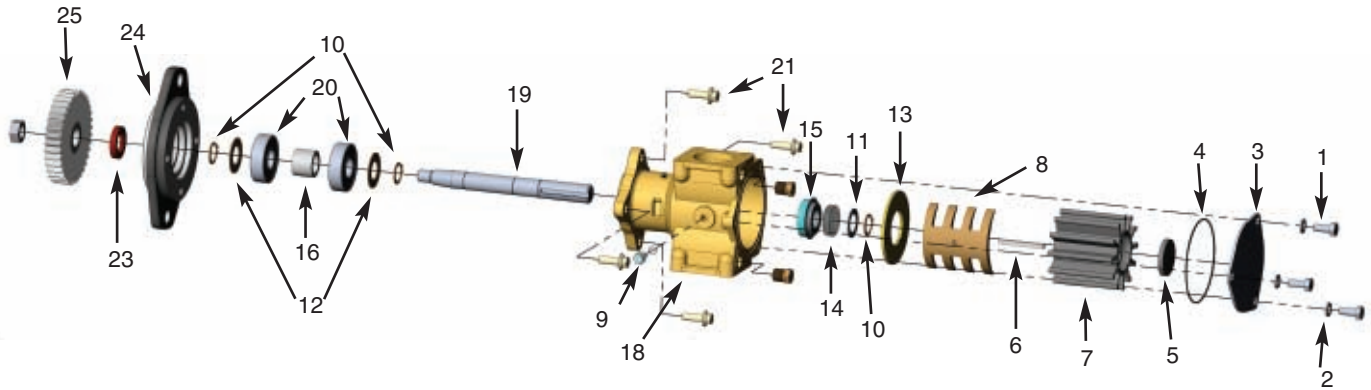
The following assembly/disassembly procedures apply to all 17000 Series pumps. Deviations from pump to pump are primarily a result of different methods of drive and mounting. Pump model numbers can be found stamped into the cover plate of the pump.

- A. Remove the three bolts (1) and lock washers (2) from the pump cover (3). The cover and o-ring (4) are now free. The impeller end cap (5) can be pried off with a screwdriver. Normally, impellers (7) can be removed by using the 23631 or 25105 impeller puller (3/4" – 16 bolt) for the 17000 threaded impeller or by using two pair of pliers to grip two of the impeller's vanes on opposite sides of the impeller. A penetrating lubricant will help loosen a stuck impeller. Also, rotating the shaft by hand may help free the impeller. The 3/16" key (6) will also be removed at this time.

- B. Remove any pulleys or drive gears (25) from the drive shaft. For tapered shaft models (all models except P173 and P1719), it is necessary to remove the shaft nut and pull the gear or pulley with a puller. For models with pressed on gears (P173), two threaded holes are provided in the gear. An appropriate puller may be attached to these two holes to remove the gear from the shaft.

- C. Most models will be equipped with a flange adapter (24). The flange adapter is held to the pump body by two socket head cap screws (21), either 3/8" or 10mm, depending on the model. The screws are removed by using a hex socket wrench. More current models are mounted with four 8mm flange hex head bolts. The adapter is then removed. If the lip seal (23) in the adapter requires replacing, it can be pressed out at this time.

- D. The cam (8) and cam screw (9) are removed. The internal wear plate (13) will drop out. The retaining ring (10), washer (11) and seal seat (14) are then removed. Pump models P1710C, P1716C, P1722C, P1727C, P1730C, P1732C, and P17XX-04 do not utilize this retaining ring and washer. For these pumps, the seal seat can be removed in step F below.

- E. From the ball bearing end, the internal snap ring (17) must be removed on models P171 through P176, P1710 and P1732. All other models have extended bearing assemblies and are held together by means of the flanged adapter.

- F. The shaft/bearing assembly (19) is pressed out of the body from the impeller end and removed from the engine end of the pump. For pump models P1710C, P1716C, P1722C, P1727C, P1730C, P1732C, and P17XX-04, the seal seat will press off of the shaft when the shaft is forced out of the pump.

- G. On earlier models, the two external snap rings (10) are removed from the shaft (19) along with the bearing washers (12), permitting removal of bearings (20). More recent designs do not utilize the bearing washers, and they have one retaining ring in-between the ball bearings. The mechanical seal (15) may now be removed by pressing it out from the bearing side of the housing (18).

- A. Press mechanical seal (15) into housing (18), using the seal pusher provided in the 25115 seal kit if applicable, with the grey silicon carbide or black carbon seal face toward the impeller.

- B. On all older model pumps with mounting adapters, the lip seal (23) will have to be replaced prior to replacing the flange adapter (24). Care should be taken to ensure proper alignment of the lip seal to the adapter and that the lip seal is uniformly pressed to prevent distortion. The metal backing ring of the lip seal goes toward the pump and away from the engine.

- C. Skip this step if the entire shaft/bearing assembly is available for the particular model that is being repaired. Install external snap ring (10) on shaft (19). Next, place washer (12), bearing (20), bearing spacer (16), second bearing (20) and washer (12) and secure with the second external snap ring (10). The bearings will have to be pressed on from the pulley/gear end. Note that it is extremely important to properly align the bearings to the shaft prior to the press, otherwise the possibility exists of galling the shaft in the area of the lip seal.

- D. Press the bearing and shaft assembly into the housing (18). In applicable pump models, replace the internal snap ring (17). The use of Loctite #262 or equivalent is recommended on the adapter bolts. The adapter (24) may be reassembled to the pump housing (18) at this time with two or four bolts (21) as applicable. Torque the adapter bolts to 18 ft-lbs.

- E. The seal seat (14) is now installed from the impeller end of the housing. The grey silicon carbide or white ceramic seat should be placed against the grey silicon carbide or black carbon seal face of the mechanical seal (15). **Caution:** Care must be taken to remove all burrs, salt buildup, and other corrosion from the keyway and seal seat area to prevent cutting the rubber cup or galling the 25115 metal seal sleeve.

- F. The internal wear plate (13) is dropped in place, anti-rotation pin aligned with the cast slot in the bottom of the housing. The cam (8) is reinstalled and secured with the cam screw (9) and cam screw o-ring. Older model cam screws were sealed by means of a nylon washer requiring Permatex or other sealant to seal the cam screw. The cam screw should be inspected to ensure that it does not protrude below the cam. This condition is possible if the nylon seal is badly deformed or if a substitute screw is used. Should the screw protrude beneath the cam, replace it with a new screw, or grind flush. Failure to do so will result in immediate impeller damage.

- G. At this time, if applicable, press on any gears (25), pulleys, or hubs onto the shaft. While pressing on the drive mechanism, the shaft (19) must be securely supported from the impeller end and in line with the press. Failure to do so will result in either damaged bearings and/or a canted gear with excessive run out. For the base model pumps P1716, P1722, P1727, P1730 and P1731, replace the tapered gear and gear nut on the shaft. Use Loctite #262 on the gear threads and torque the nut to 50 ft-lbs. For all other tapered gear and shaft assemblies, see the applicable engine manufacturers' requirements for thread sealant and torque specifications.

- I. Install the impeller (7) using a non-petroleum based lubricant such as silicon or soapy water. **Note:** Do not use petroleum-based fluids as they will damage the impeller. The impeller is installed using a twisting motion. Ensure the impeller blades are bent in the same direction as upon removal. Once installed, rotate the shaft to align keyway and slide the key (6) in place (not applicable for the plunged key designs P1710C, P1732C, and equivalent P17XX-04). **Note:** The 2" key found in the 17000K is used in all models other than the designs P1710C, P1732C, and equivalent P17XX-04. Cover the key hole in the impeller insert with the rubber end plug (5). **Caution:** Failure to place the plug in place on the 17000A impeller will cause the key to walk out of the shaft keyway and damage the cover. The 17000 impeller requires that the key be placed on the shaft prior to installation.

- J. Replace the cover o-ring (4), cover (3), lock washers (2), and the cover cap screws (1). Torque the cap screws to 14 ft-lbs.
Note: If the cover is replaced with a new one, record the information on the original cover to help identify the pump for future repairs and maintenance.
